Problematic Foam Generation in Wind Turbine Gearboxes: Causes & Treatment

Kurtis Hartlen, Imperial Oil; Andrea Williamson, Imperial Oil; Michael Blumenfeld, ExxonMobil; Marianne Rodgers, Robbie Sanderson, Wind Energy Institute of Canada;

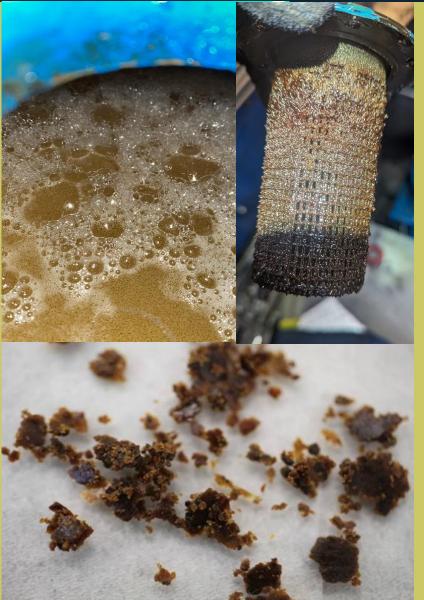
Deposits & Foam

- At WEICan gearboxes with in-service foaming also suffered from zinc-based deposits
- Foam preceded by oil darkening and an increase in
