Case Study: A Novel Silicone Foam Dressing for Stage III Pressure Injury

Kelsey Resler, AGNP, CWCN | AZ Wound & Hyperbaric Medicine, Gilbert, AZ

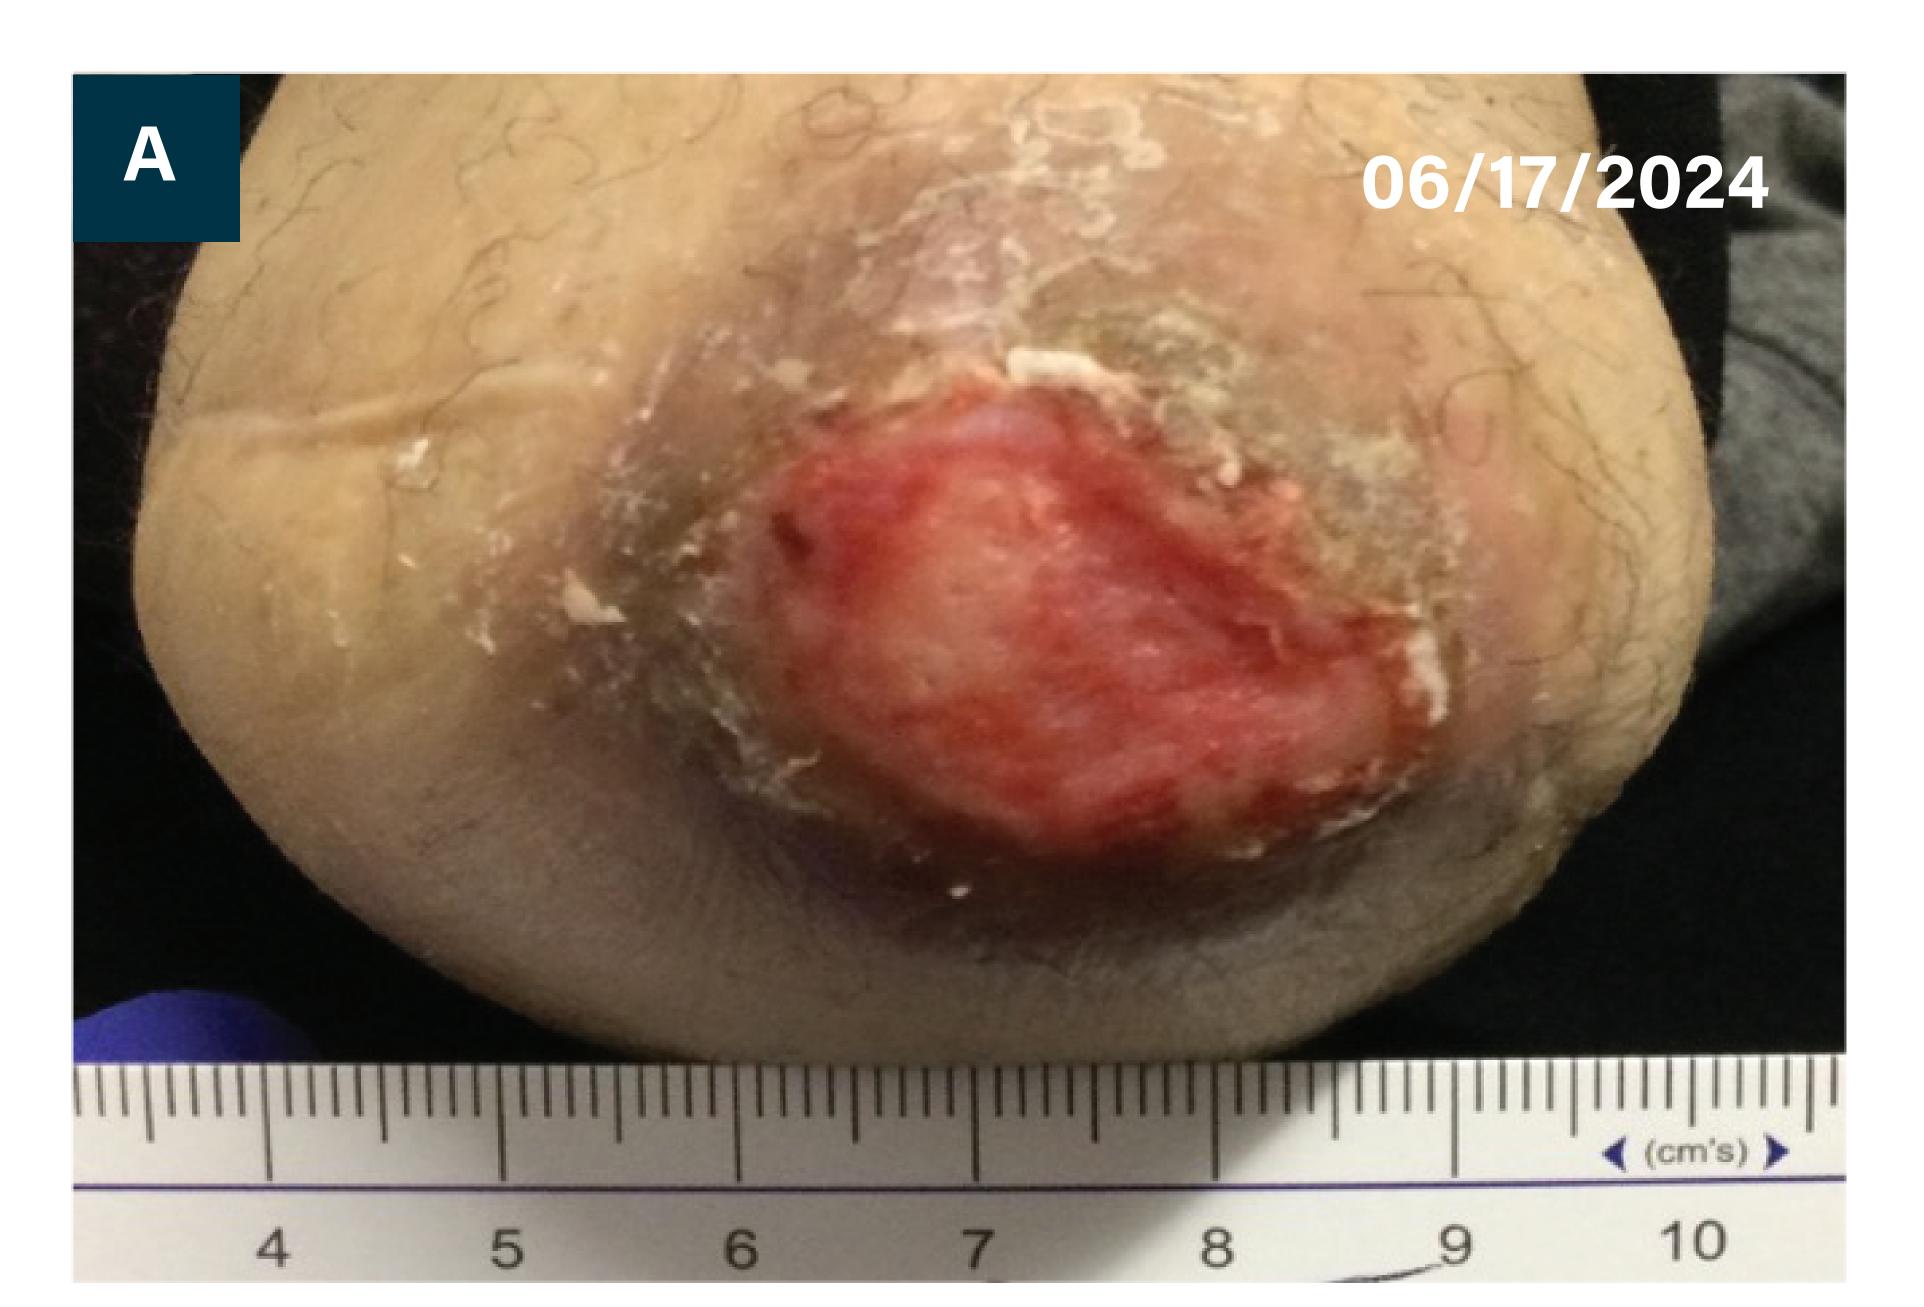
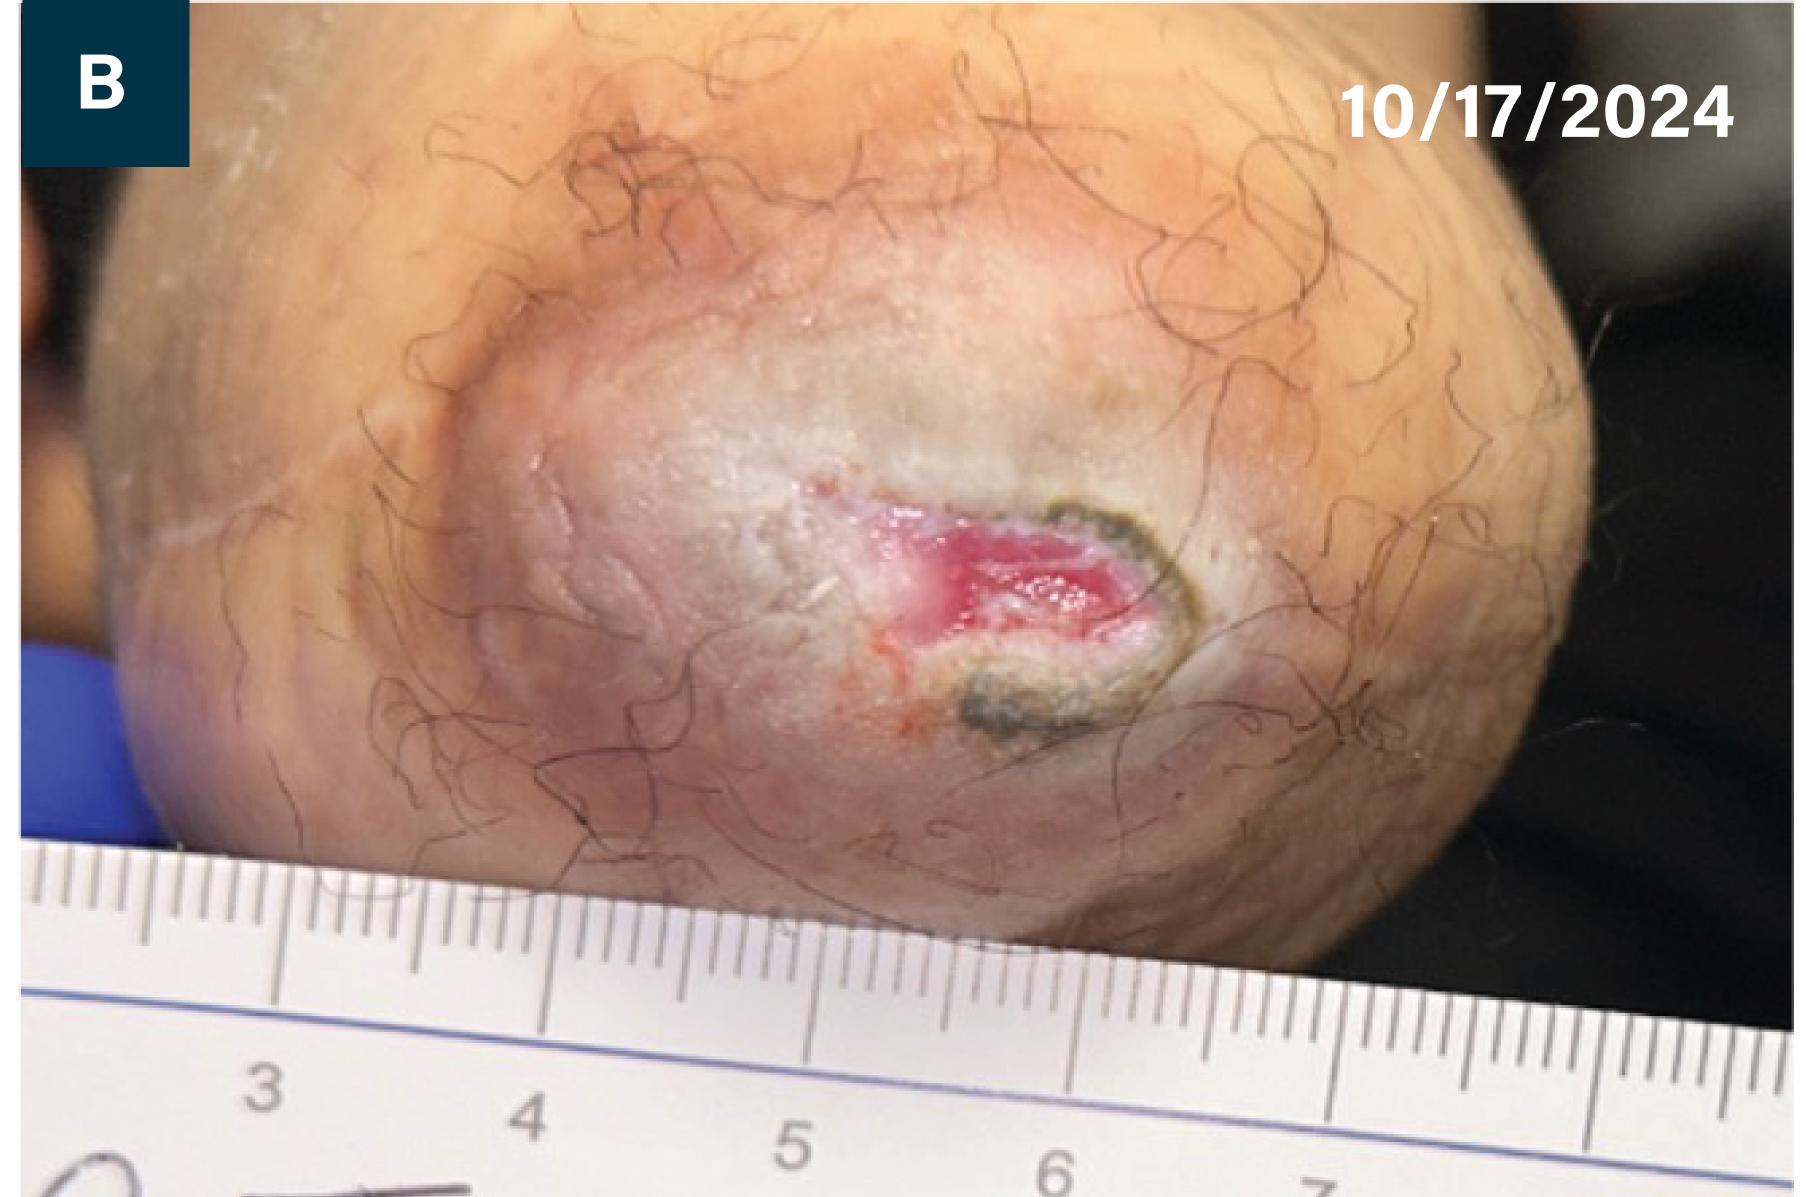
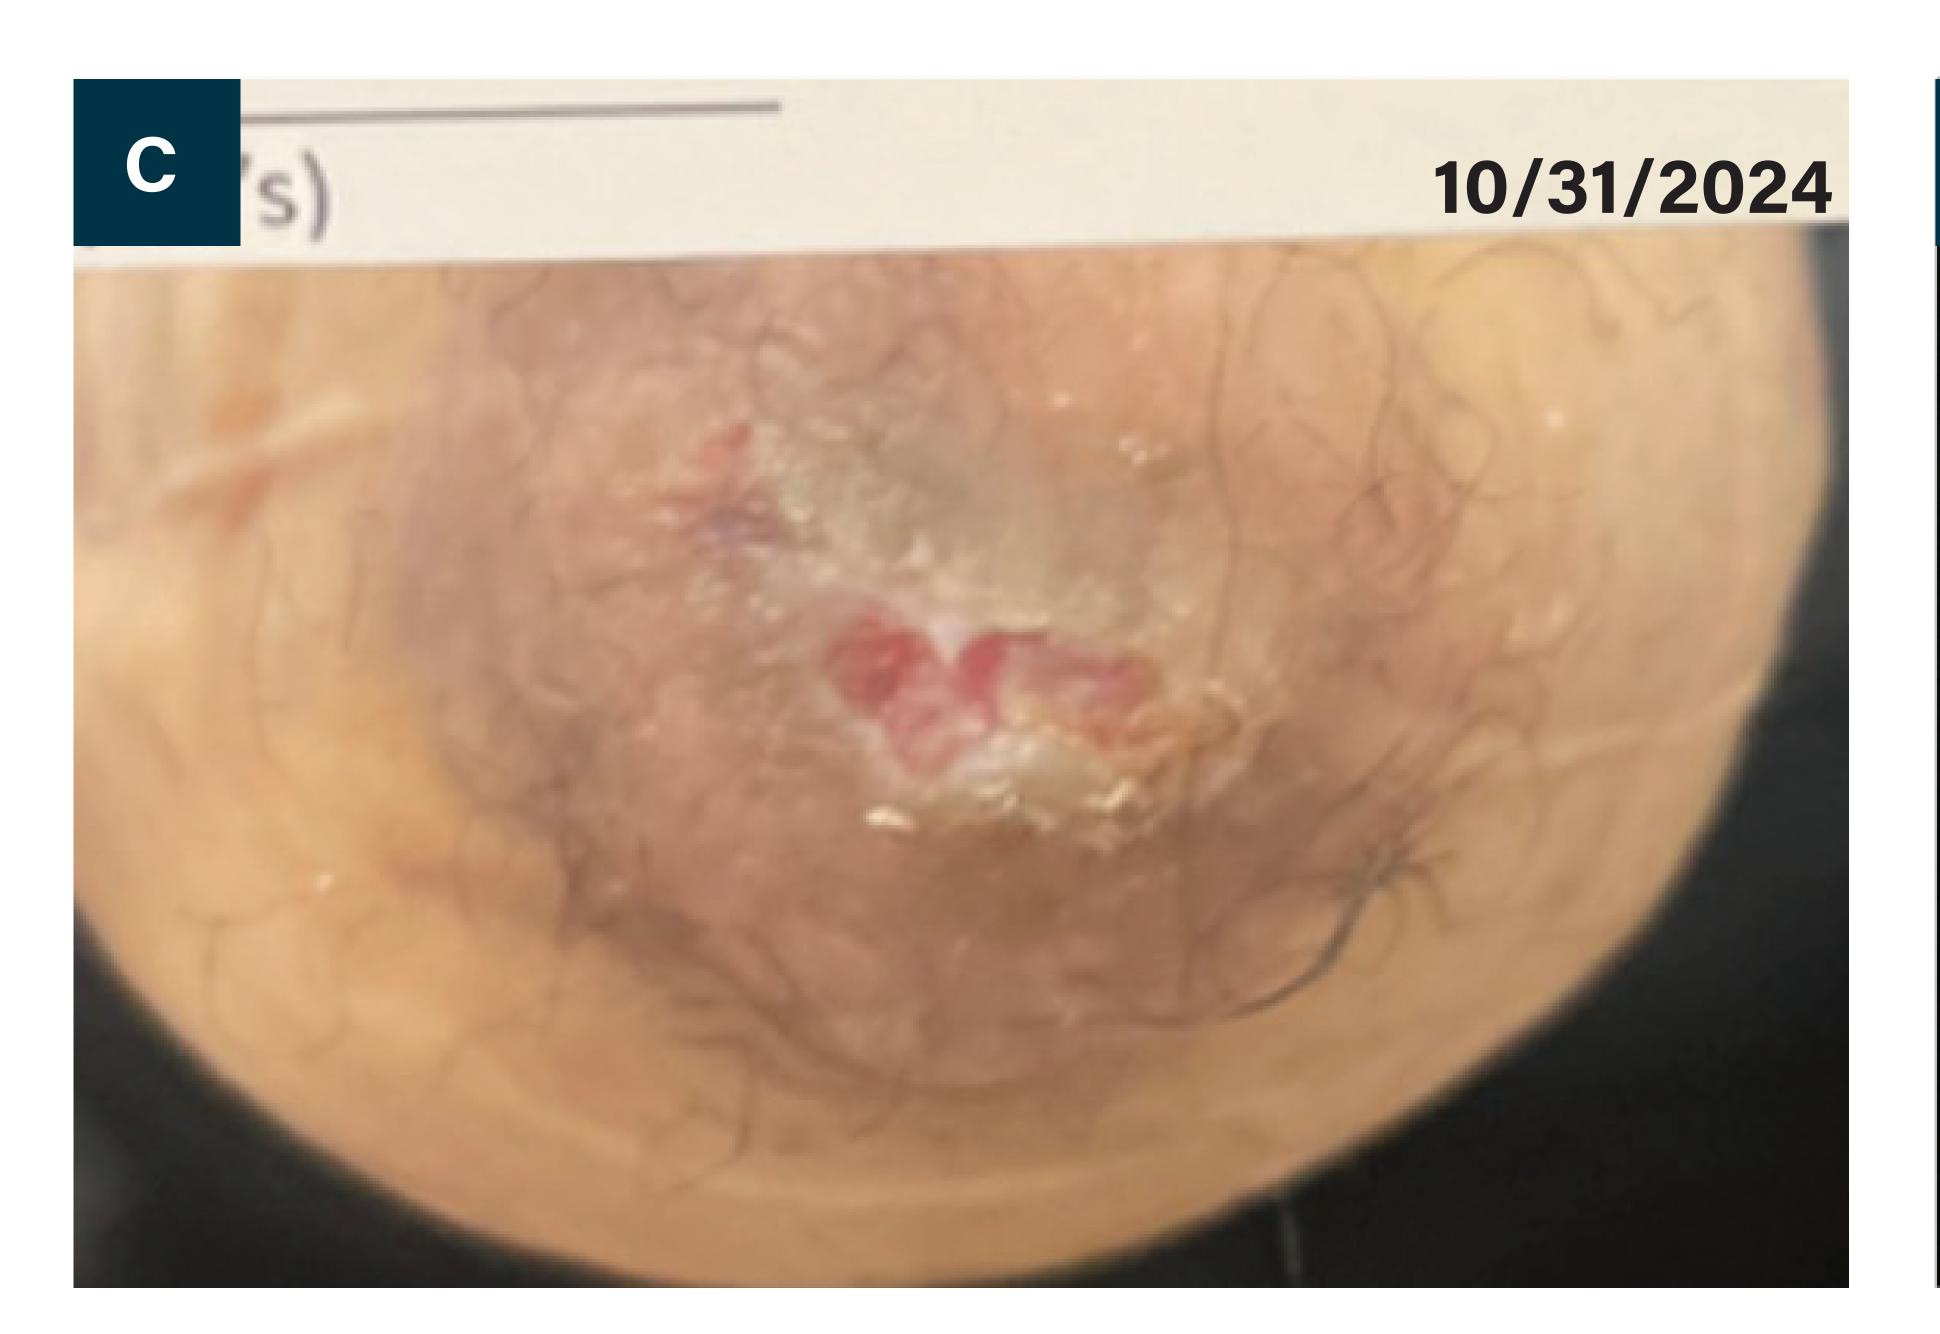
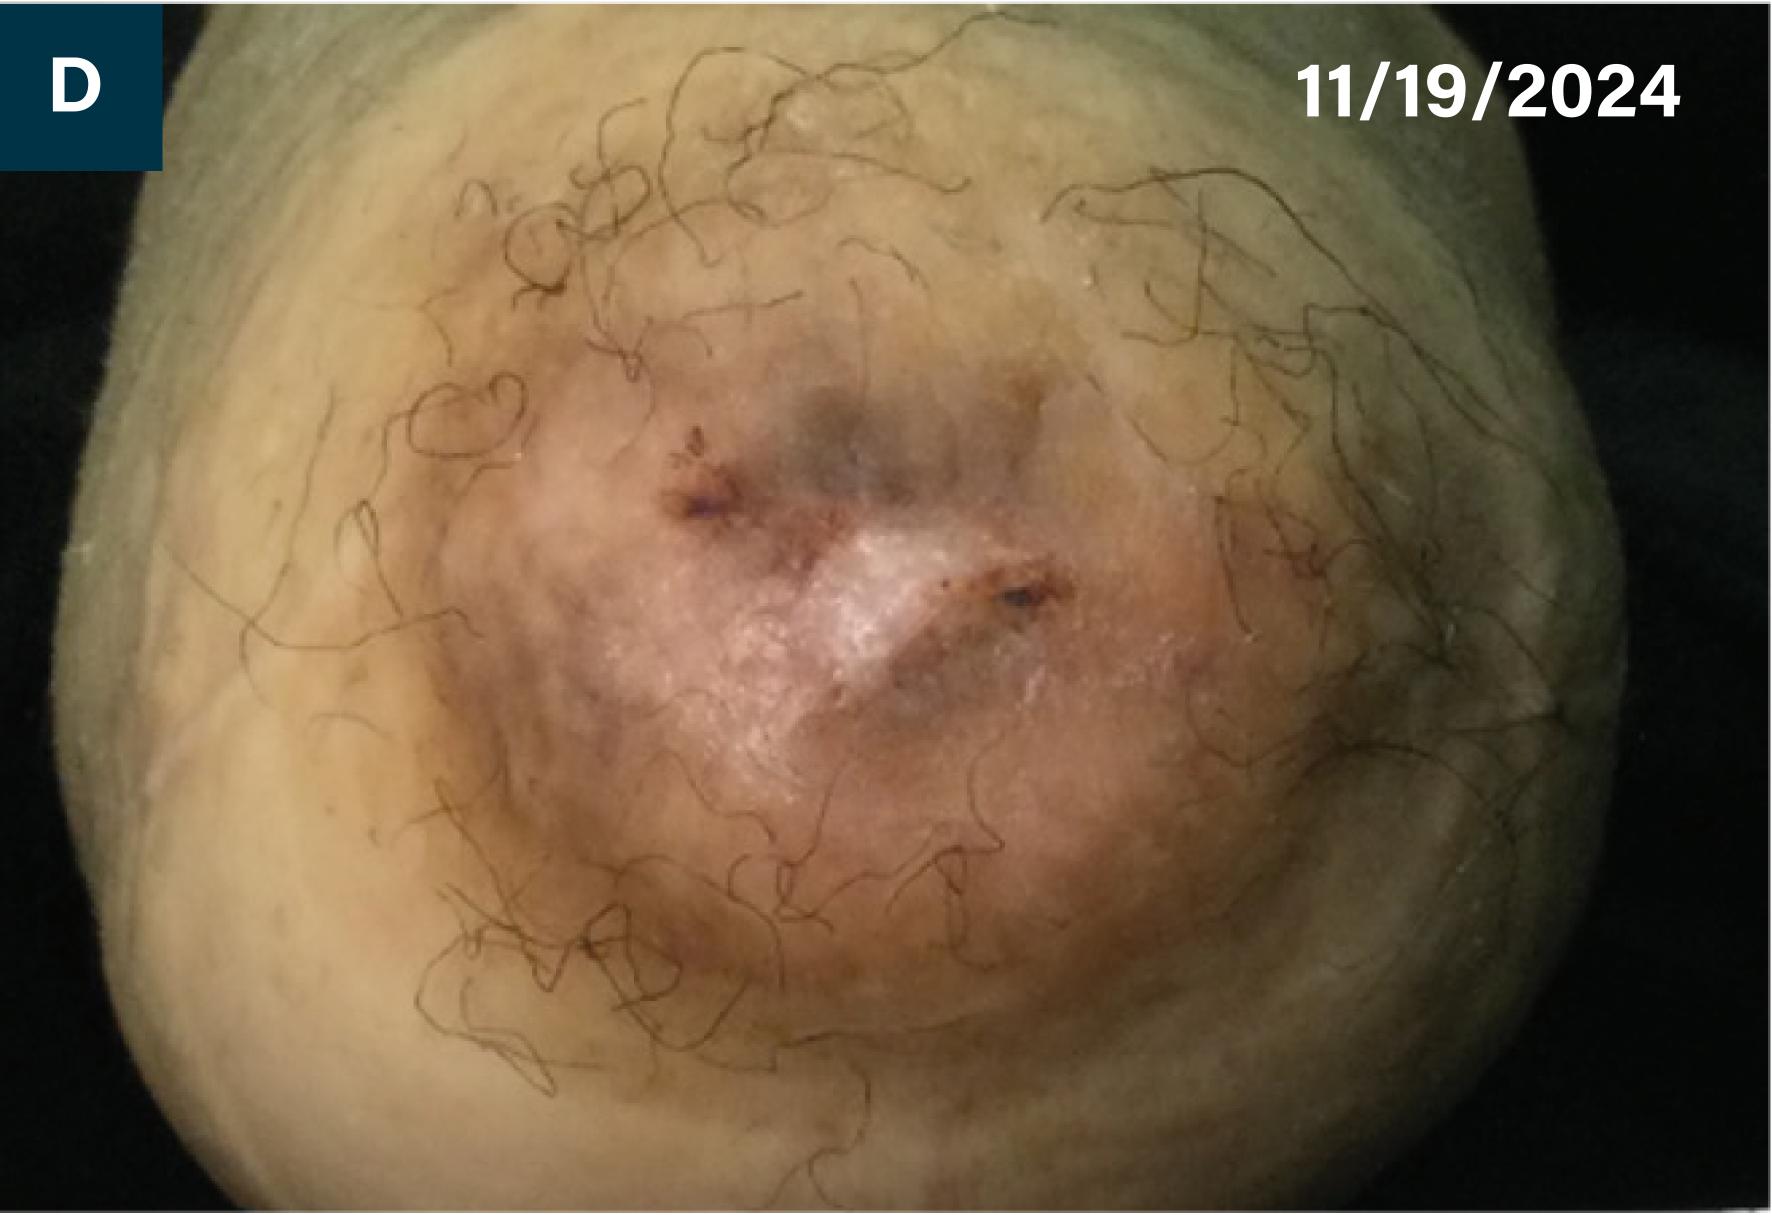
Figure. A 52-year-old female with controlled type 2 diabetes, hypertension, dyslipidemia, anemia, and gout presented with a chronic pressure injury secondary to prosthetic use to the left BKA. (A) At initial visit, the wound had a volume of 4.3 cm². The chronic wound was treated with weekly sharp debridement and a variety of topical standards of care with improvement but no resolution. (B) Just prior to initiating the proprietary silicone foam dressing,* the wound had a volume of 1.8 cm². (C) After 2 weeks of using the silicone foam dressing.

After 4 months, patient was initiated on a proprietary silicone foam dressing.*

- 52-year-old female with chronic pressure injury stage III secondary to prosthetic use at BKA site
- History of type 2 diabetes (last HgbA1C: 6.0%), anemia, gout, hypertension, and hyperlipidemia
- Wound age at presentation was 9 months
- Over 4 months, patient completed weekly in-office sharp debridement with multiple topical treatments trialed (ie, silver nitrate, xeroform, hydrocolloid, collagen foams, hydrogel collagen, cadexomer iodine, and silver sulfadiazine cream)
- Once-weekly, in-office dressing changes of the silicone foam dressing post debridements and once weekly by the patient at home were started
- Patient did not use the prosthetic for the duration of treatment
- After 1 month of utilizing the silicone foam dressings, the patient's wound was fully closed with no callus, moisture, or concerns at the healed site

The silicone foam dressings helped to control exudate and filled in depth entirely with no breakdown or moisture to the periwound with use. The dressings were easy for the patient to change at home. It also helped reduce the overall cost of supplies for the patient and wound clinic.
