Problematic Foam Generation in Wind Turbine Gearboxes: Causes & Treatment

Kurtis Hartlen, Imperial Oil; Andrea Williamson, Imperial Oil; Michael Blumenfeld, ExxonMobil; Marianne Rodgers, Robbie Sanderson, Wind Energy Institute of Canada;

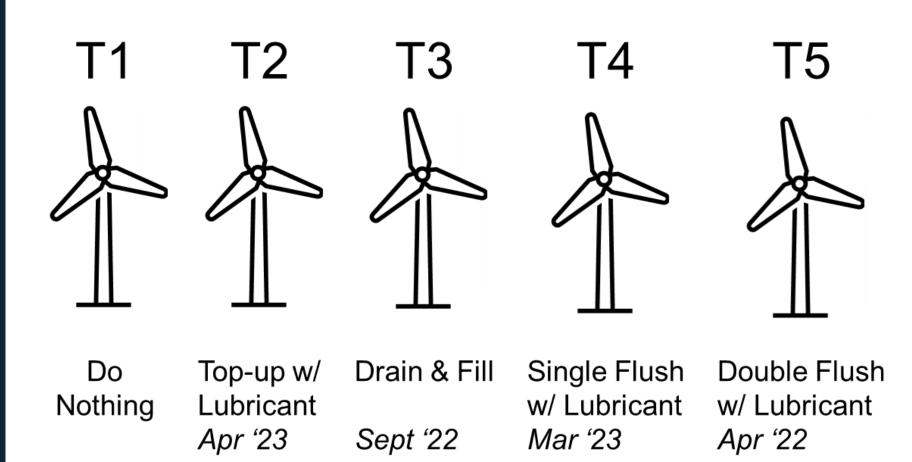
Performing an Oil Change...260 feet up in the air

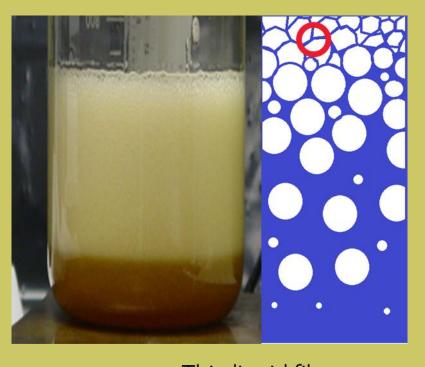
- Foams ultimately separate into liquid and gas phases
- Foams collapse when the liquid film becomes unstable
- Anti-foam additives help destabilize the film
- Gravity and capillary forces cause the film to drain/thin
- Good lubricants accelerate film drainage and promote

Thin liquid film Air / gas Gravity Forces =

film rupture
